Moisture Inspection Report

Inspected for
John Doe
123 Stucco Road
Houston, TX 77XXX
01/01/01

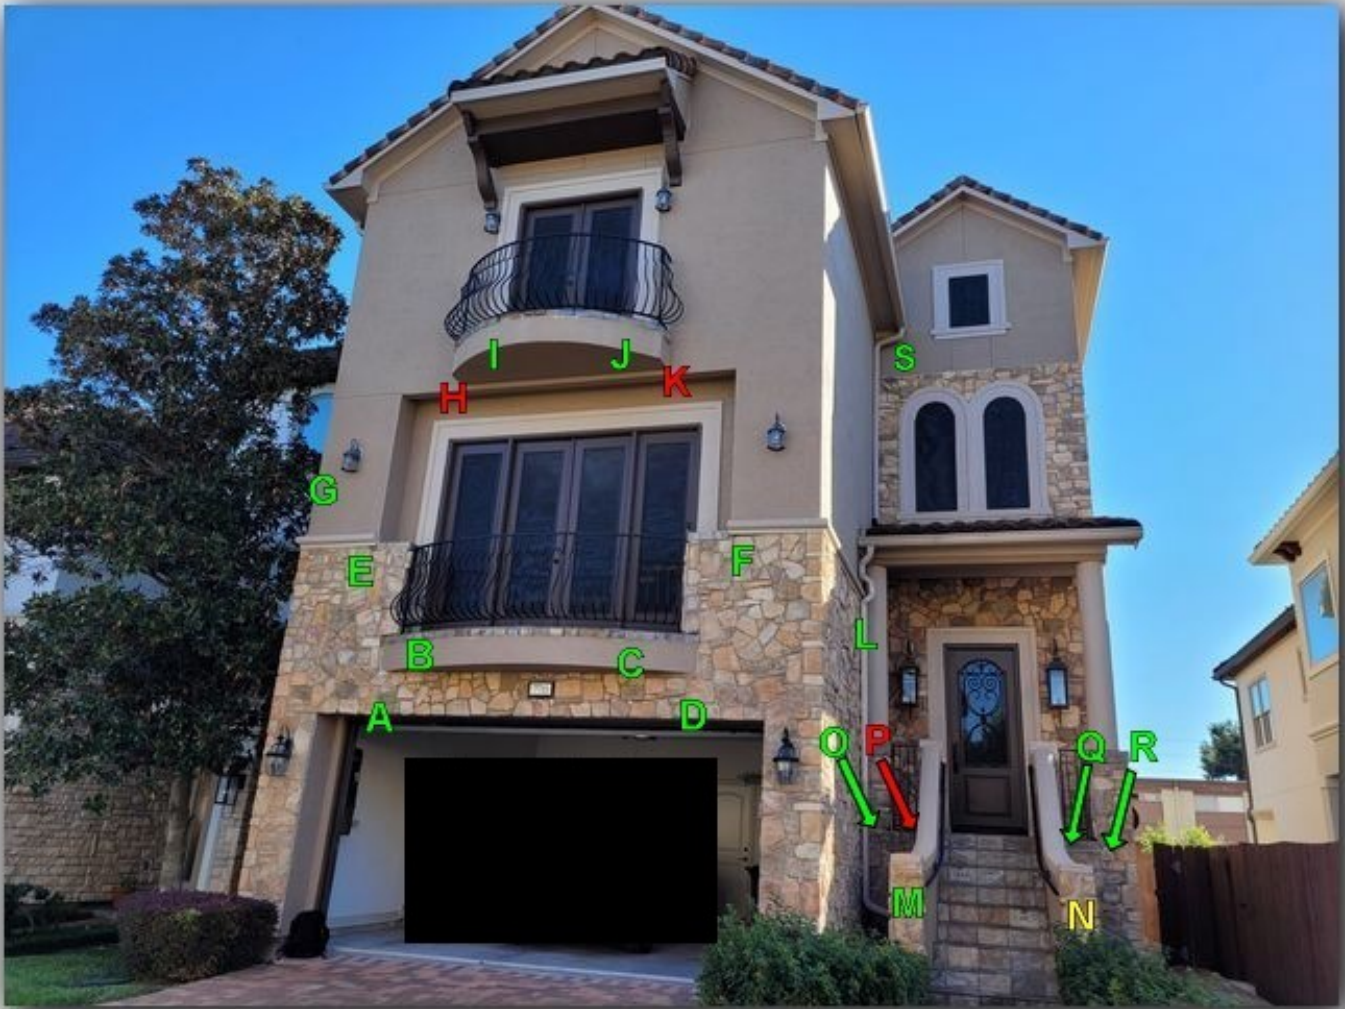
Moisture Testing (1)

Test Location	Moisture Content	Substrate Condition	Additional comments
A	<15%	Firm	Drainage relief not present.
B	<15%	Firm	Drainage relief not present.
C	<15%	Firm	Drainage relief not present.
D	<15%	Firm	Drainage relief not present.
E	<15%	Firm	Flat / low slope surfaces
F	<15%	Firm	Flat / low slope surfaces
G	<15%	Firm	Corner cracks above needing repair.
H	N/A	None present	No substrate was observed when drilling/probing. This is an indication of moisture damage / wood rot. Diverter flashing not installed at balcony intersection.Drainage relief not present.
I	<15%	Firm	Drainage relief not present.
J	<15%	Firm	Drainage relief not present.
K	N/A	None present	No substrate was observed when drilling/probing. This is an indication of moisture damage / wood rot. Diverter flashing not installed at balcony intersection.Drainage relief not present.
L	<15%	Firm	
M	<15%	Firm	Improper clearance from grade (soil / mulch).

N	15-19%	Firm	Improper clearance from grade (soil / mulch).

O	<15%	Firm	Diverter flashing not installed at landing and wall intersection.
P	N/A	Soft	Soft substrate was observed when drilling/probing. This is an indication of moisture damage / wood rot. Diverter flashing not installed at landing and wall intersection.
Q	<15%	Firm	Diverter flashing not installed at landing and wall intersection.
R	<15%	Firm	Diverter flashing not installed at landing and wall intersection.
S	<15%	Firm

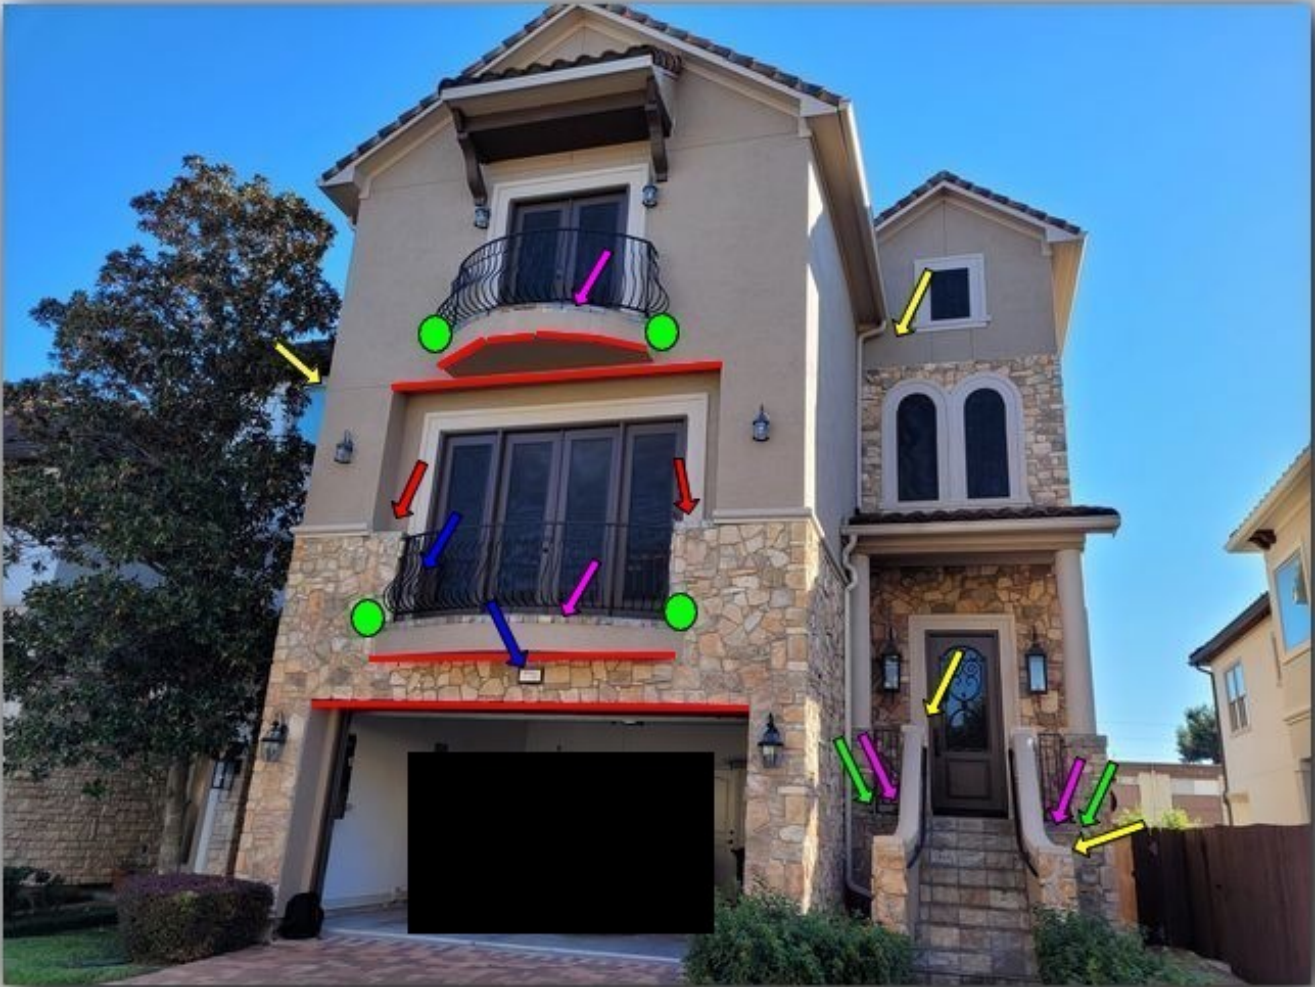
Deficiencies (1)

Identifier	Comments
Blue Arrows	Damaged / Aged / Missing Sealant: Damaged, aged, and / or missing sealant was found at wall penetrations, joints, windows, and / or other voids on the exterior. Properly installed sealant provides a barrier against moisture intrusion. Recommend repairs using a top quality, low modulus, polyurethane sealant or sealant recommended by the manufacturer of your system.
Yellow Arrows	Cracks Present: Cracks were found at the stucco cladding. Hairline cracks (generally 1/16 of an inch) are commonly found with stucco systems. These cracks should be monitored and repaired as needed. It is recommend that cracks larger than hairline are repaired by a qualified stucco contractor. It is important to understand that all cracks may not be individually identified when a high quantity of cracking is present.
Green Arrows and Dots	Balcony Diverter Flashing Missing: Diverter flashing has not been installed at the wall and balcony intersections. Diverter flashing helps to prevent moisture intrusion and allow water to properly drain away from the wall. It is recommended to install diverter flashing when elevated moisture or damage is covered as a result of the missing flashing.

Pink Arrows	Tiles On Drip Edge Flashing: Tiles have been installed on the drip edge flashing. Tiles can prevent water from draining as intended and can cause rust to occur. Removal of the tiles is recommended. Once the tiles have been removed, it is recommended that the drip edge flashing is inspected for damage or rust.

Red Arrows	Flat / Low Sloped Surface: Flat / low slope surfaces were observed at the 2nd floor balcony. Flat / low slope surfaces may be more prone to moisture intrusion, damage, cracking, and standing water. Recommend installing waterproofing methods to prevent damages from occurring.
Red Lines	Missing Drainage Openings: Drainage openings are not installed at the stucco walls / soffit. Drainage openings assist with allowing incidental moisture to escape. Incidental moisture can become trapped in these enclosed areas, sometimes referred to as a "stucco bucket". This trapped moisture can lead to wood rot at the substrate and framing. If elevated moisture or possible substrate / framing damage was found, a drainage opening should be installed during repairs.

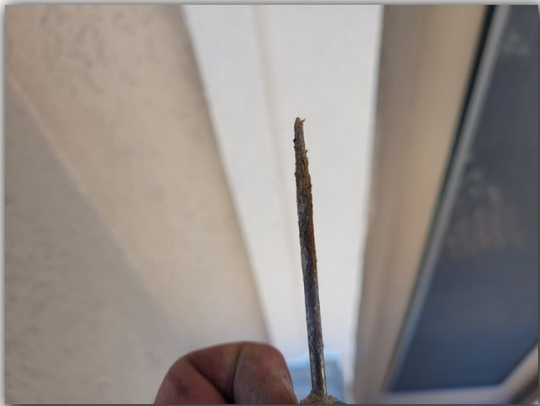
1 - 1: Moisture Intrusion: Areas of elevated moisture and / or possible substrate / framing damage was found at the following locations as reported on the "Moisture Testing" page:

Elevated Moisture - Refer to the *Moisture Testing* page for the moisture readings at each test location. If elevated moisture readings are found during the inspection, this can indicate that active water penetrations exist near the area. Water intrusion can occur from voids at penetrations, cracks, improper installation, improper clearance, missing flashing details, and any other items that may be listed on this report. It is recommended that any areas with the potential for leaks to occur, as stated in this report, are addressed and repaired by a qualified stucco contractor.

Soft or Missing Substrate - Refer to the *Moisture Testing* page for the condition of the substrate at each test location. If the substrate is not firm when inserting the moisture meter probes, this can indicate possible wood rot / damage due to previous or active water penetrations in the area near the probed location.

1- 1.1 Test Location H - Dark / discolored wood on probe - Indication of wood rot

Repair Process: It is recommended that these areas be further assessed and repaired by a qualified stucco contractor, as needed. Core sampling or inspection holes should be performed by your contractor to confirm any suspected substrate and / or framing damage found by the inspector. Test locations are not representative of the total area of suspected damage, but provide information on general areas where repairs may be needed. Typical repairs to remedy soft or missing substrate include doing a partial tear-off of the stucco around the location until clean dry substrate is found and repairing as needed. During repairs, the total area any underlying damage should be determined by your contractor. It is important to thoroughly review and understand the scope of work in the repair proposal provided by your contractor. In addition, it is recommended to discuss the potential for "Change Orders" that may occur once work begins.

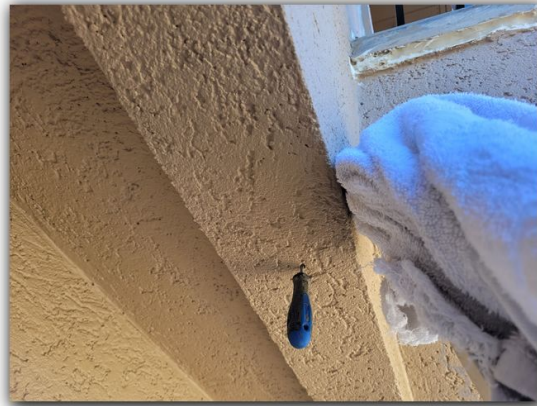
1- 1.2 Test Location H - No substrate encountered

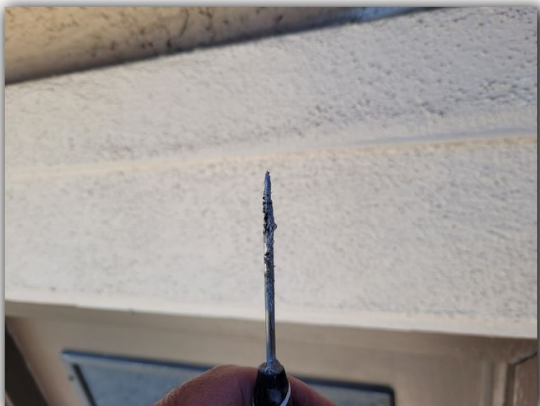
1- 1.3 Test Location K - Dark / discolored wood on probe - indication of wood rot

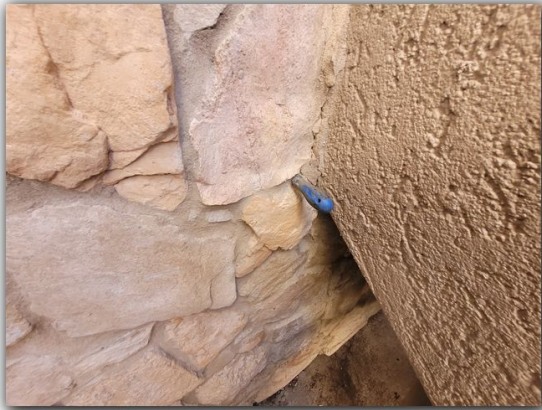
1- 1.5 Test Location P - Soft substrate encountered

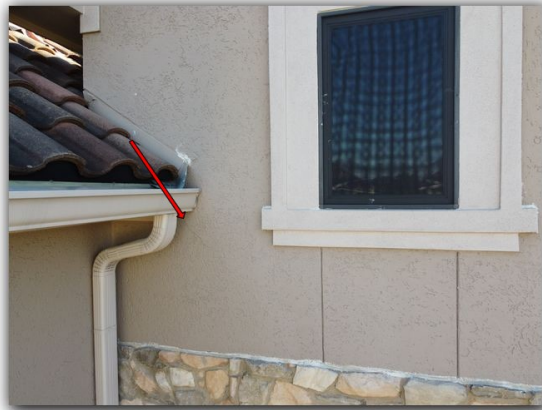
1- 2.1

1 - 2: Cracks Present: Cracks were found at the stucco cladding. Hairline cracks (generally 1/16 of an inch) are commonly found with stucco systems. These cracks should be monitored and repaired as needed. It is recommended that cracks larger than hairline are repaired by a qualified stucco contractor. It is important to understand that all cracks may not be individually identified when a high quantity of cracking is present.

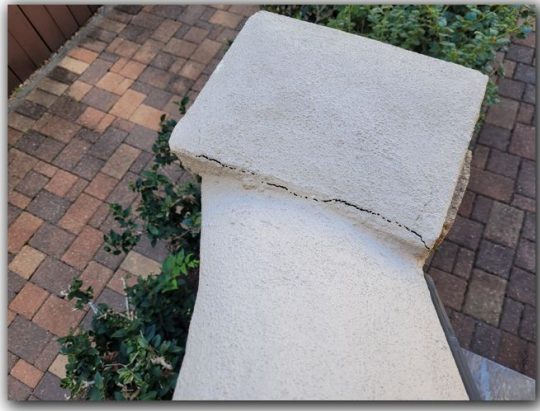
1- 2.4 Cracks - right side of stairs

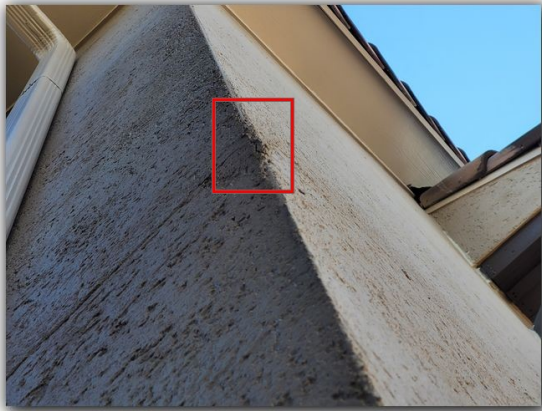
1- 2.5 Corner crack at the control joint

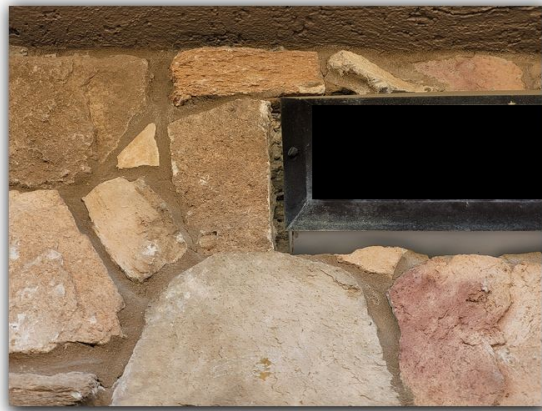
1 - 3: Damaged / Aged / Missing Sealant: Damaged, aged, and / or missing sealant was found at wall penetrations, joints, windows, and / or other voids on the exterior. Properly installed sealant provides a barrier against moisture intrusion. Recommend repairs using a top quality, low modulus, polyurethane sealant or sealant recommended by the manufacturer of your system.

1- 3.1 Mortar missing. Recommend sealing sign with mortar.

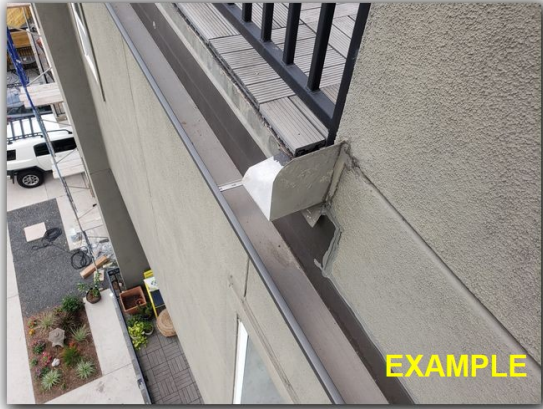
1- 4.1

1 - 4: Balcony Diverter Flashing Missing: Diverter flashing has not been installed at the wall and balcony intersections. Diverter flashing helps to prevent moisture intrusion and allow water to properly drain away from the wall. It is recommended to install diverter flashing when elevated moisture or damage is covered as a result of the missing flashing.

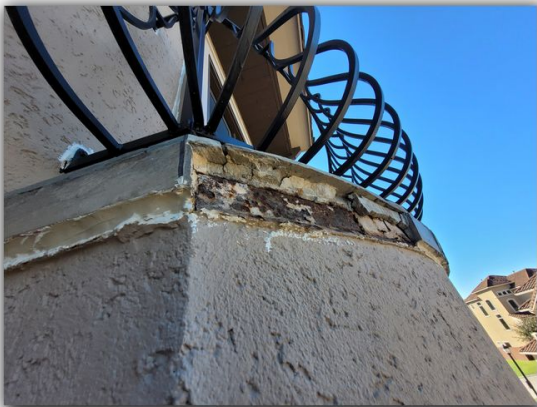
1 - 5: Tiles On Drip Edge Flashing: Tiles have been installed on the drip edge flashing. Tiles can prevent water from draining as intended and can cause rust to occur. Removal of the tiles is recommended. Once the tiles have been removed, it is recommended that the drip edge flashing is inspected for damage or rust.

1- 5.1 Rusted drip edge flashing due to tiles

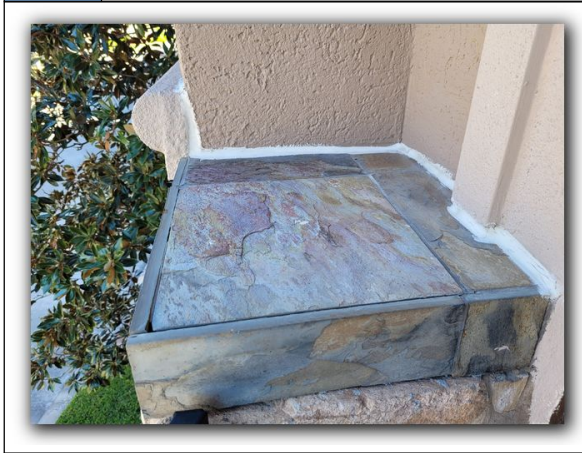
1- 6.1

1 - 6: Flat / Low Sloped Surface: Flat / low slope surfaces were observed at the 2nd floor balcony. Flat / low slope surfaces may be more prone to moisture intrusion, damage, cracking, and standing water. Recommend installing waterproofing methods to prevent damages from occurring.

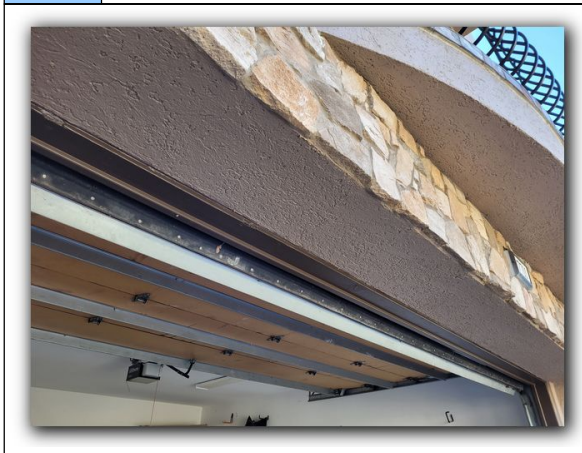
1- 7.1

1 - 7: Missing Drainage Openings: Drainage openings are not installed at the stucco walls / soffit. Drainage openings assist with allowing incidental moisture to escape. Incidental moisture can become trapped in these enclosed areas, sometimes referred to as a "stucco bucket". This trapped moisture can lead to wood rot at the substrate and framing. If elevated moisture or possible substrate / framing damage was found, a drainage opening should be installed during repairs.

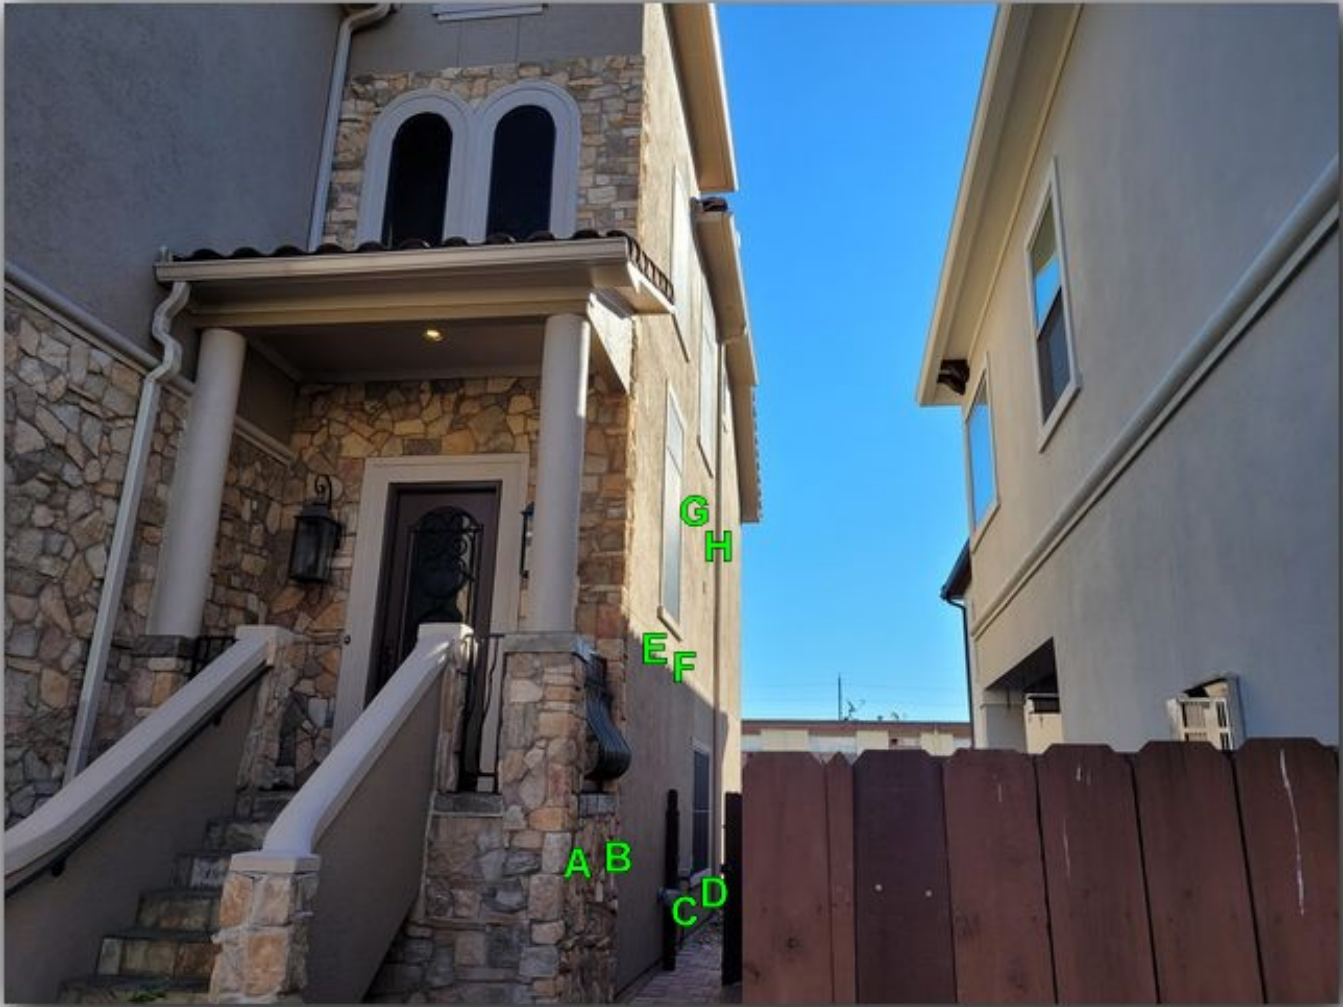
Moisture Testing (2)

Test Location	Moisture Content	Substrate Condition	Additional comments
A	<15%	Firm	Diverter flashing not installed at landing and wall intersection.
B	<15%	Firm	Diverter flashing not installed at landing and wall intersection.
C	<15%	Firm	
D	<15%	Firm	
E	<15%	Firm	
F	<15%	Firm	
G	<15%	Firm	
H	<15%	Firm

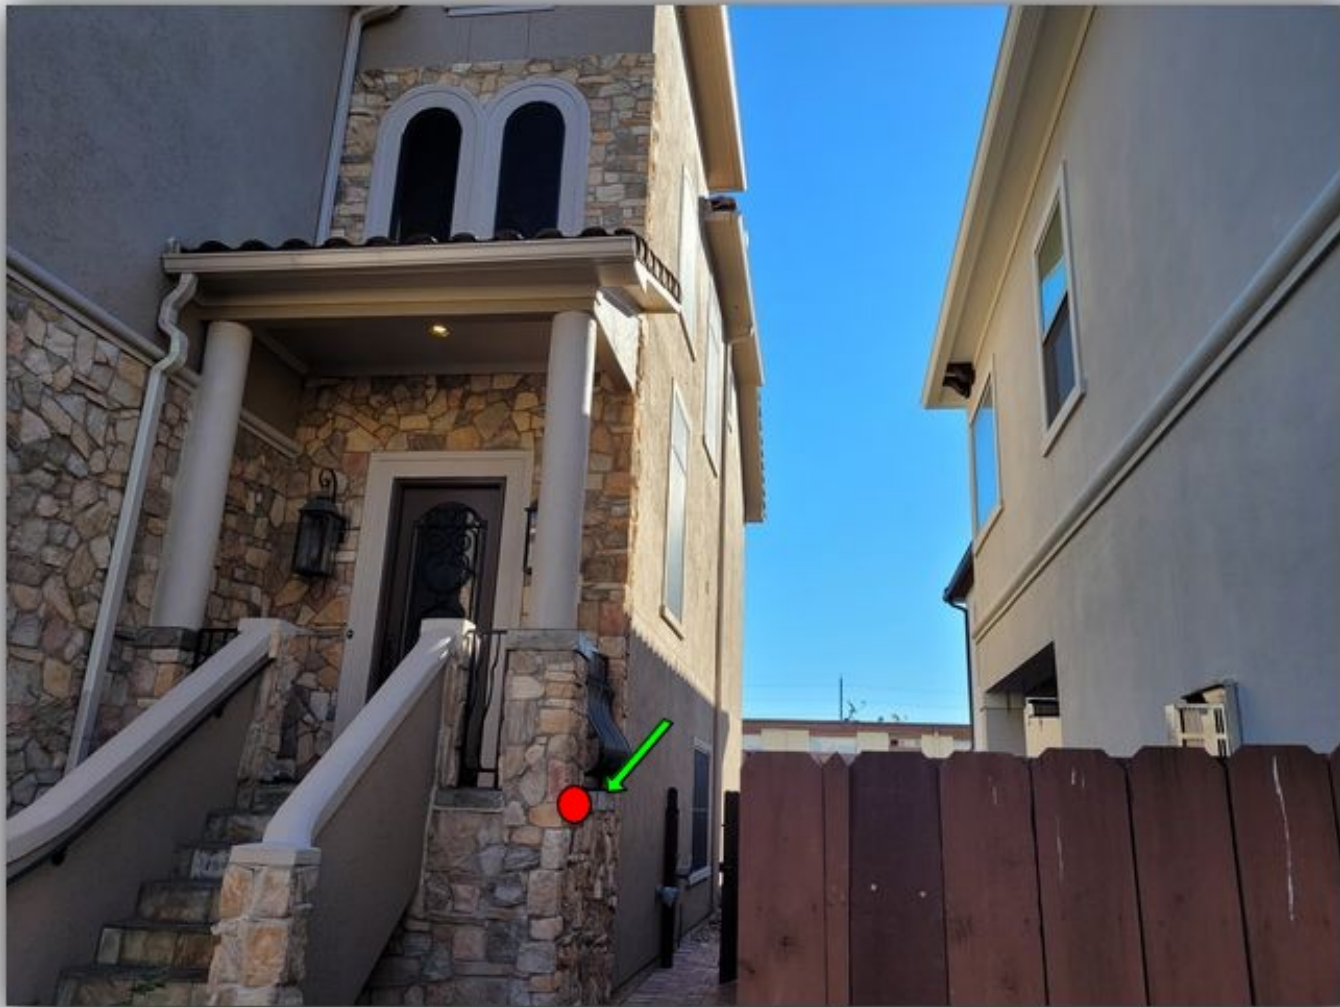
Deficiencies (2)

Identifier	Comments
Red Dot	Balcony Diverter Flashing Missing: Diverter flashing has not been installed at the wall and balcony intersections. Diverter flashing helps to prevent moisture intrusion and allow water to properly drain away from the wall. It is recommended to install diverter flashing when elevated moisture or damage is covered as a result of the missing flashing.
Green Arrow	Tiles On Drip Edge Flashing: Tiles have been installed on the drip edge flashing. Tiles can prevent water from draining as intended and can cause rust to occur. Removal of the tiles is recommended. Once the tiles have been removed, it is recommended that the drip edge flashing is inspected for damage or rust.

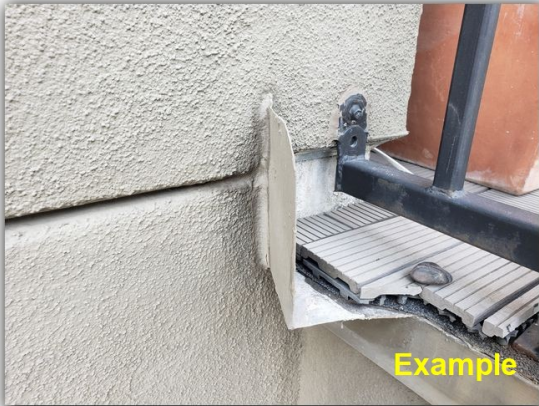
2- 1.1

2 - 1: Balcony Diverter Flashing Missing: Diverter flashing has not been installed at the wall and balcony intersections. Diverter flashing helps to prevent moisture intrusion and allow water to properly drain away from the wall. It is recommended to install diverter flashing when elevated moisture or damage is covered as a result of the missing flashing.

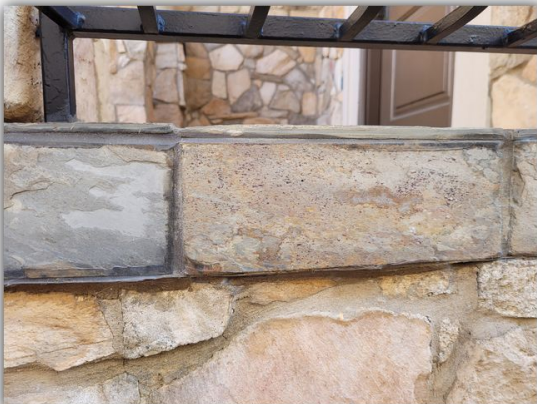
2- 2.1

2 - 2: Tiles On Drip Edge Flashing: Tiles have been installed on the drip edge flashing. Tiles can prevent water from draining as intended and can cause rust to occur. Removal of the tiles is recommended. Once the tiles have been removed, it is recommended that the drip edge flashing is inspected for damage or rust.

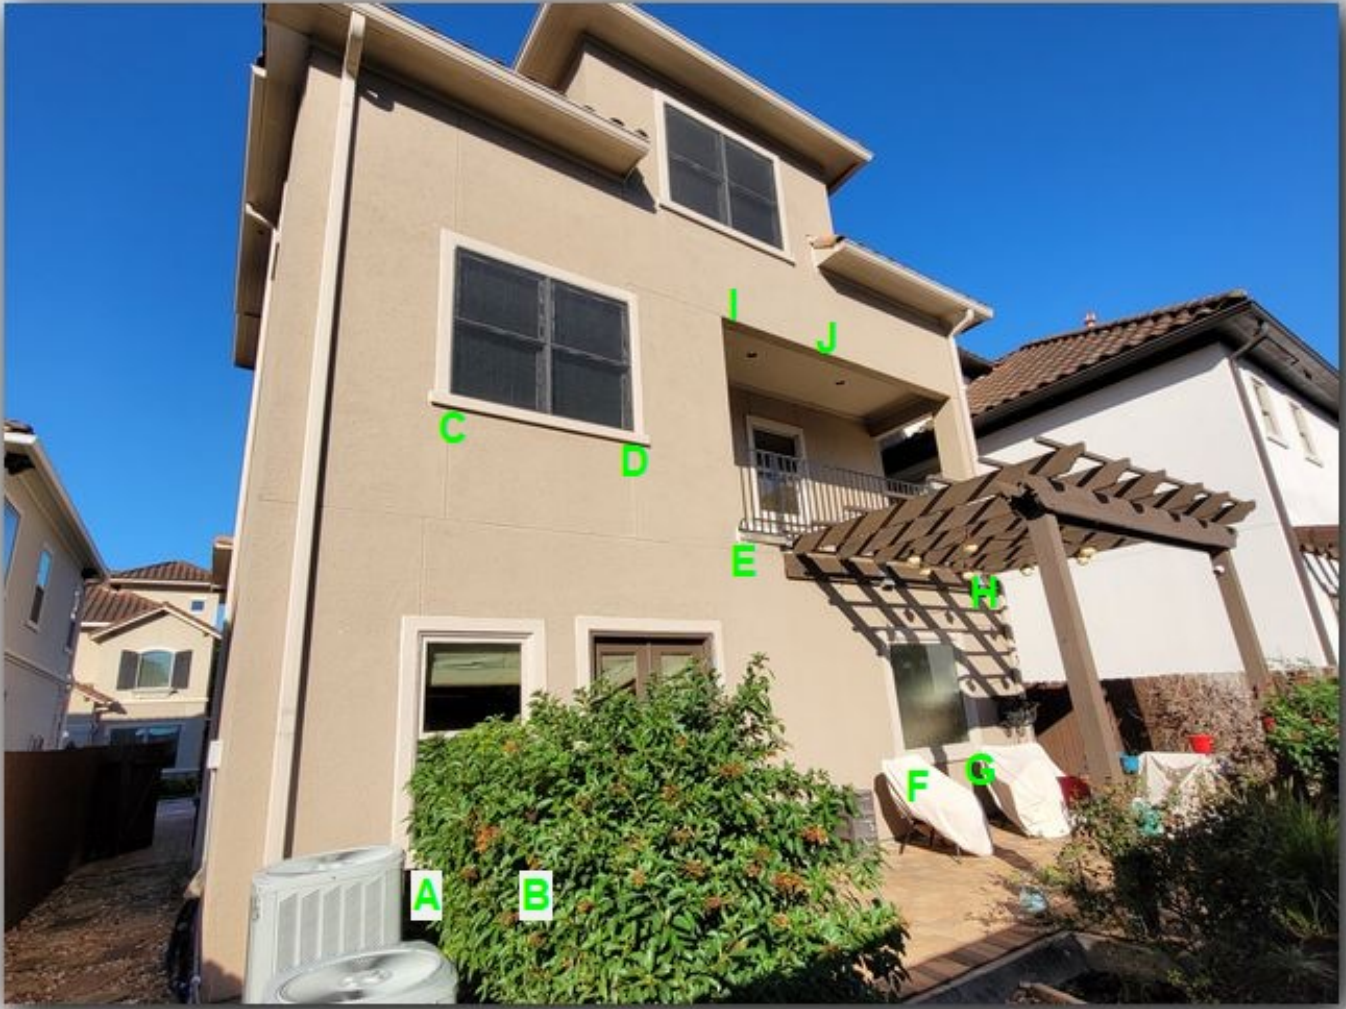
Rear Side of Structure Moisture Testing (3)

Test Location	Moisture Content	Substrate Condition	Additional comments
A	<15%	Firm	Damaged / aged sealant at windows.
B	<15%	Firm	Damaged / aged sealant at windows.
C	<15%	Firm	Damaged / aged sealant at windows.
D	<15%	Firm	Damaged / aged sealant at windows.
E	<15%	Firm	Diverter flashing not installed at balcony intersection.
F	<15%	Firm	
G	<15%	Firm	
H	<15%	Firm	Diverter flashing not installed at balcony intersection.
I	<15%	Firm	Drainage relief not present.
J	<15%	Firm	Drainage relief not present.

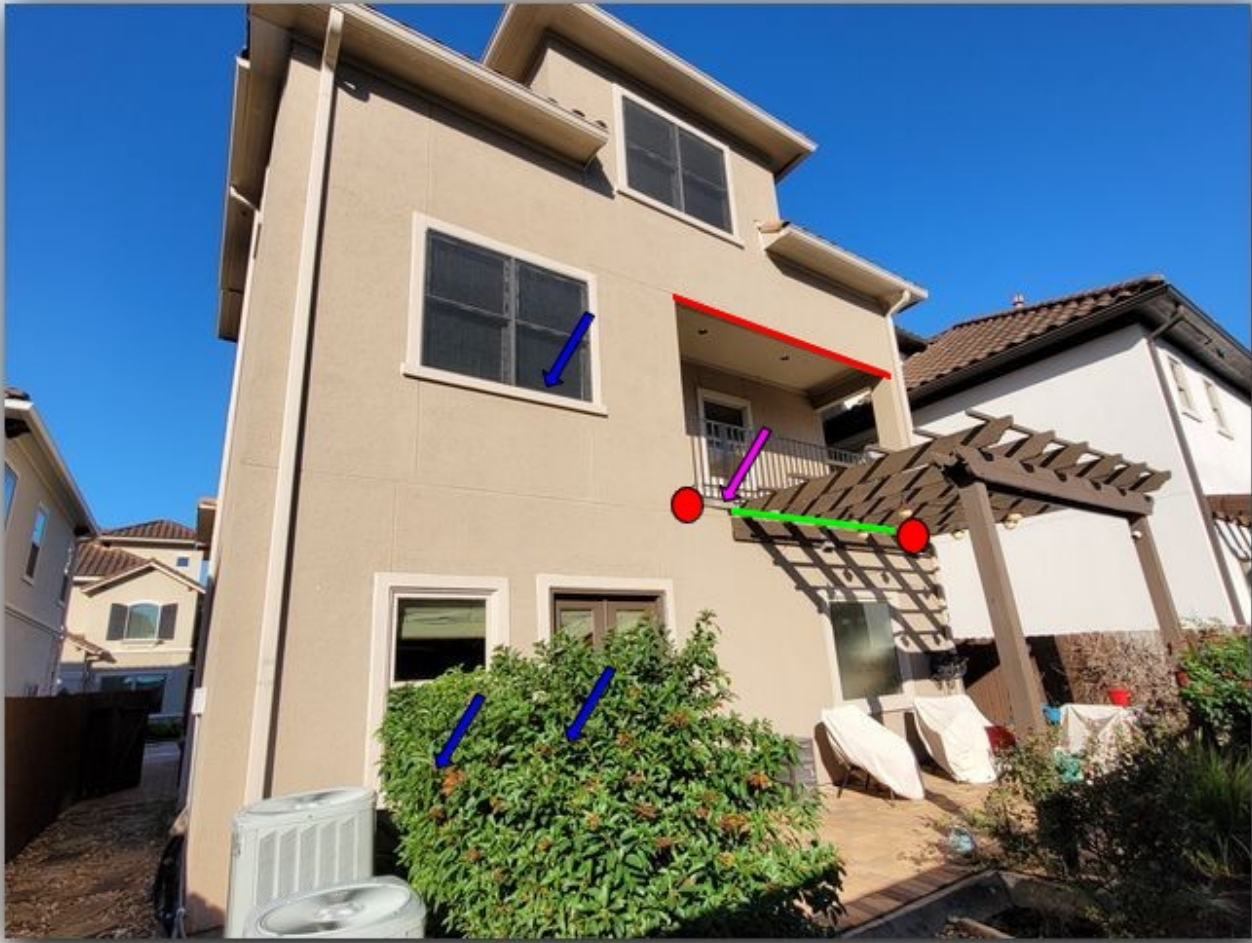
Rear Side of Structure Deficiencies (3)

Identifier	Comments
Blue Arrows	Damaged / Aged / Missing Sealant: Damaged, aged, and / or missing sealant was found at wall penetrations, joints, windows, and / or other voids on the exterior. Properly installed sealant provides a barrier against moisture intrusion. Recommend repairs using a top quality, low modulus, polyurethane sealant or sealant recommended by the manufacturer of your system.
Pink Arrow	Tiles On Drip Edge Flashing: Tiles have been installed on the drip edge flashing. Tiles can prevent water from draining as intended and can cause rust to occur. Removal of the tiles is recommended. Once the tiles have been removed, it is recommended that the drip edge flashing is inspected for damage or rust.
Red Dots	Balcony Diverter Flashing Missing: Diverter flashing has not been installed at the wall and balcony intersections. Diverter flashing helps to prevent moisture intrusion and allow water to properly drain away from the wall. It is recommended to install diverter flashing when elevated moisture or damage is covered as a result of the missing flashing.

Green Line	Missing Z-Flashing: Z-flashing was not installed above the ledger board for the pergola at the rear exterior. Z-flashing helps prevent moisture intrusion. At minimum, the sealants at this location should be maintained in good condition.
Red Line	Missing Drainage Openings: Drainage openings are not installed at the stucco walls / soffit. Drainage openings assist with allowing incidental moisture to escape. Incidental moisture can become trapped in these enclosed areas, sometimes referred to as a "stucco bucket". This trapped moisture can lead to wood rot at the substrate and framing. If elevated moisture or possible substrate / framing damage was found, a drainage opening should be installed during repairs.

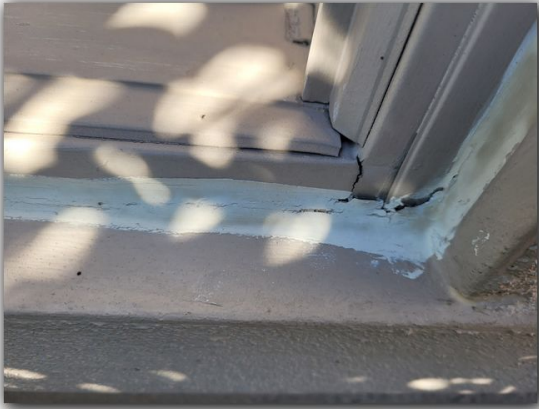
3 - 1: Damaged / Aged / Missing Sealant: Damaged, aged, and / or missing sealant was found at wall penetrations, joints, windows, and / or other voids on the exterior. Properly installed sealant provides a barrier against moisture intrusion. Recommend repairs using a top quality, low modulus, polyurethane sealant or sealant recommended by the manufacturer of your system.

3- 1.1 Seal window

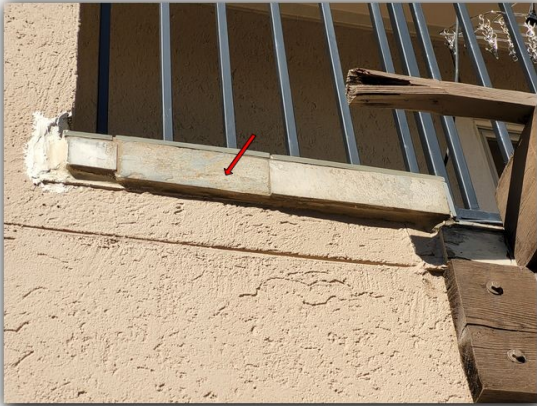
3- 2.1

3 - 2: Tiles On Drip Edge Flashing: Tiles have been installed on the drip edge flashing. Tiles can prevent water from draining as intended and can cause rust to occur. Removal of the tiles is recommended. Once the tiles have been removed, it is recommended that the drip edge flashing is inspected for damage or rust.

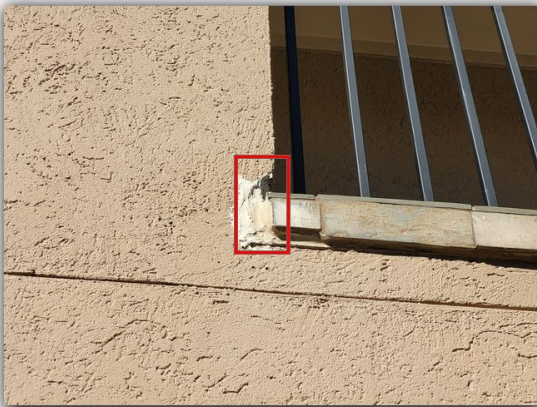
3- 3.1

3 - 3: Balcony Diverter Flashing Missing: Diverter flashing has not been installed at the wall and balcony intersections. Diverter flashing helps to prevent moisture intrusion and allow water to properly drain away from the wall. It is recommended to install diverter flashing when elevated moisture or damage is covered as a result of the missing flashing.

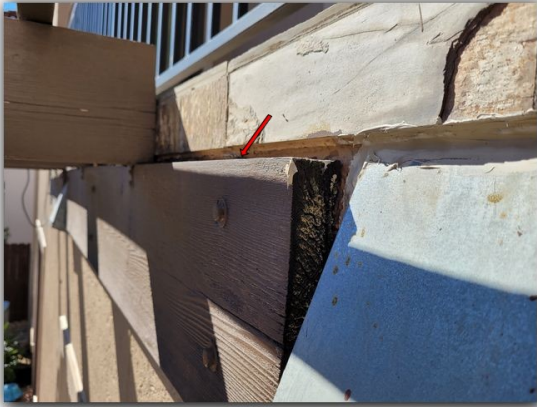
3- 4.1

3 - 4: Missing Z-Flashing: Z-flashing was not installed above the ledger board for the pergola at the rear exterior. Z-flashing helps prevent moisture intrusion. At minimum, the sealants at this location should be maintained in good condition.

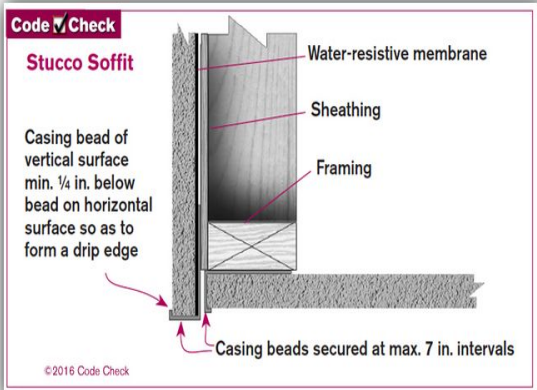
3- 5.1

3 - 5: Missing Drainage Openings: Drainage openings are not installed at the stucco walls / soffit. Drainage openings assist with allowing incidental moisture to escape. Incidental moisture can become trapped in these enclosed areas, sometimes referred to as a "stucco bucket". This trapped moisture can lead to wood rot at the substrate and framing. **If** elevated moisture or possible substrate / framing damage was found, a drainage opening should be installed during repairs.

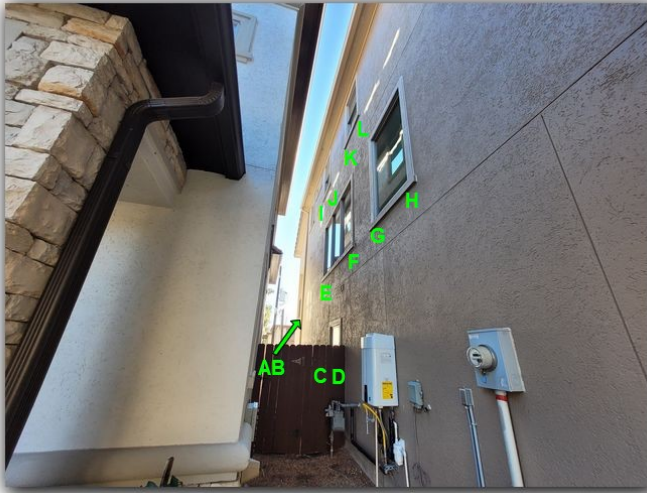
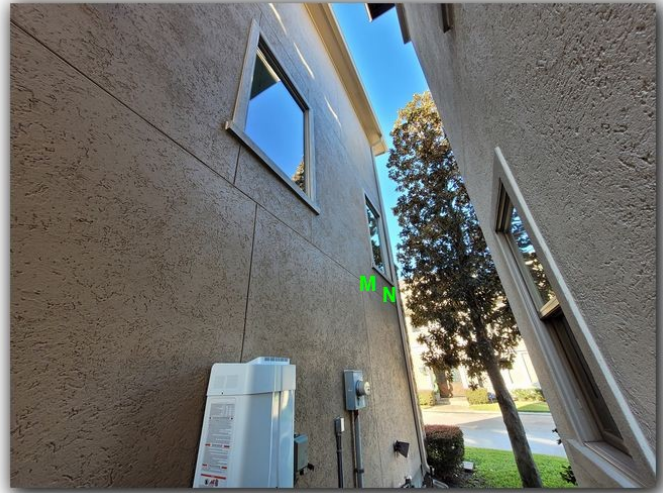
Left Side of Structure Moisture Testing (4)

Test Location	Moisture Content	Substrate Condition	Additional comments
A	<15%	Firm	Diverter flashing not installed at balcony intersection.
B	<15%	Firm	Diverter flashing not installed at balcony intersection.
C	<15%	Firm	
D	<15%	Firm	
E	<15%	Firm	
F	<15%	Firm	
G	<15%	Firm	
H	<15%	Firm	
I	<15%	Firm	
J	<15%	Firm	
K	<15%	Firm	
L	<15%	Firm	
M	<15%	Firm	
N	<15%	Firm

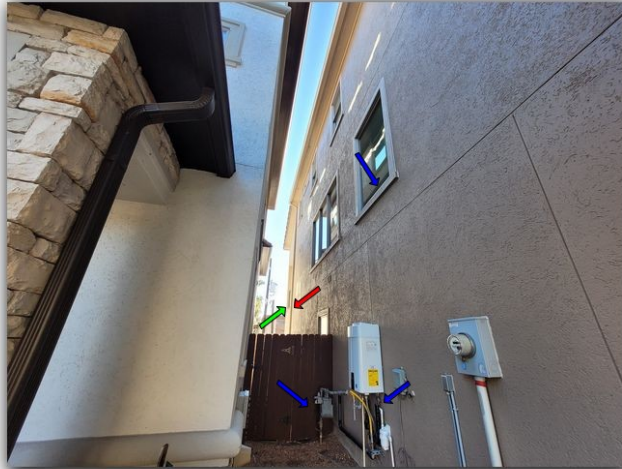
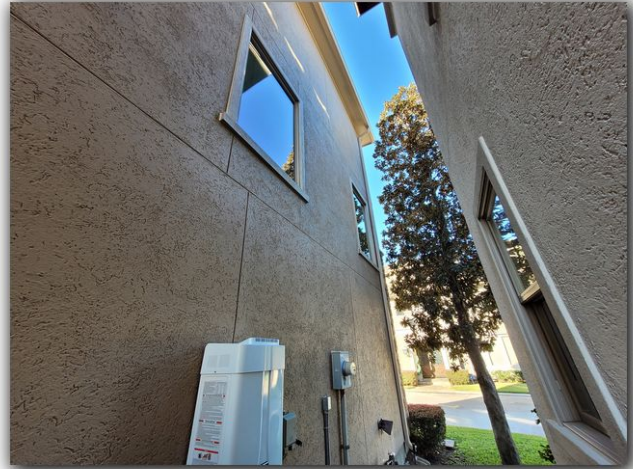
Left Side of Structure Deficiencies (4)

Identifier	Comments
Blue Arrows	Damaged / Aged / Missing Sealant: Damaged, aged, and / or missing sealant was found at wall penetrations, joints, windows, and / or other voids on the exterior. Properly installed sealant provides a barrier against moisture intrusion. Recommend repairs using a top quality, low modulus, polyurethane sealant or sealant recommended by the manufacturer of your system.
Green Arrow	Tiles On Drip Edge Flashing: Tiles have been installed on the drip edge flashing. Tiles can prevent water from draining as intended and can cause rust to occur. Removal of the tiles is recommended. Once the tiles have been removed, it is recommended that the drip edge flashing is inspected for damage or rust.
Red Arrow	Balcony Diverter Flashing Missing: Diverter flashing has not been installed at the wall and balcony intersections. Diverter flashing helps to prevent moisture intrusion and allow water to properly drain away from the wall. It is recommended to install diverter flashing when elevated moisture or damage is covered as a result of the missing flashing.

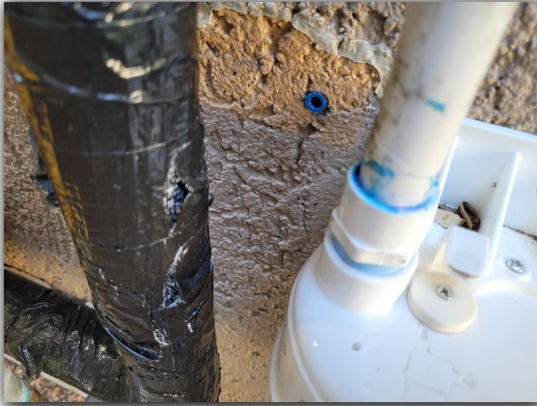
4 - 1: Damaged / Aged / Missing Sealant: Damaged, aged, and / or missing sealant was found at wall penetrations, joints, windows, and / or other voids on the exterior. Properly installed sealant provides a barrier against moisture intrusion. Recommend repairs using a top quality, low modulus, polyurethane sealant or sealant recommended by the manufacturer of your system.

4- 1.1 Remove unused anchors and seal holes

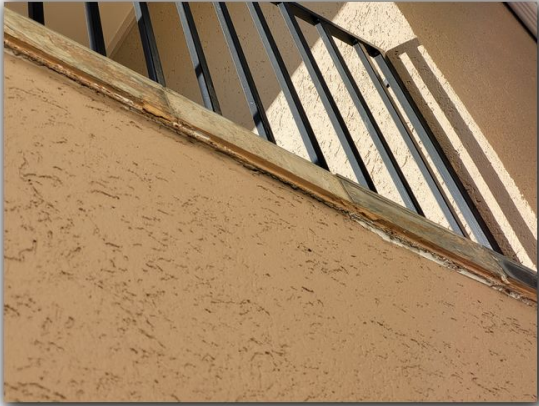
4- 2.1

4 - 2: Tiles On Drip Edge Flashing: Tiles have been installed on the drip edge flashing. Tiles can prevent water from draining as intended and can cause rust to occur. Removal of the tiles is recommended. Once the tiles have been removed, it is recommended that the drip edge flashing is inspected for damage or rust.

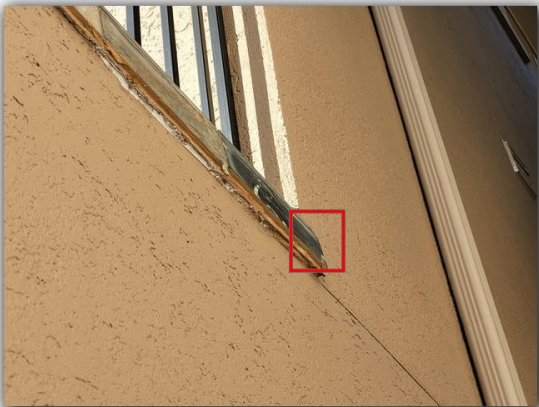
4- 3.1

4 - 3: Balcony Diverter Flashing Missing: Diverter flashing has not been installed at the wall and balcony intersections. Diverter flashing helps to prevent moisture intrusion and allow water to properly drain away from the wall. It is recommended to install diverter flashing when elevated moisture or damage is covered as a result of the missing flashing.

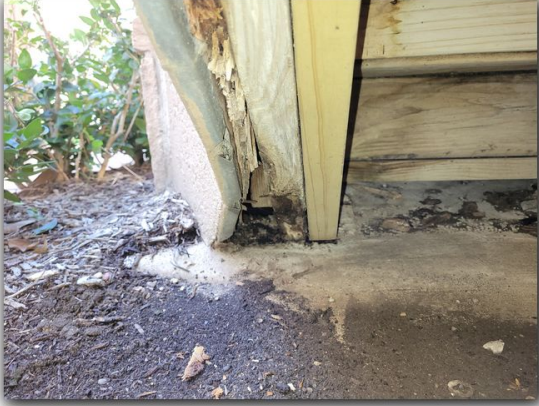
G- 1.1

G - 1: Leaks at Stairs: Signs of leaks (stains/discolorations) were observed at the stairs. It is recommended to consult a qualified contractor to repair as needed.

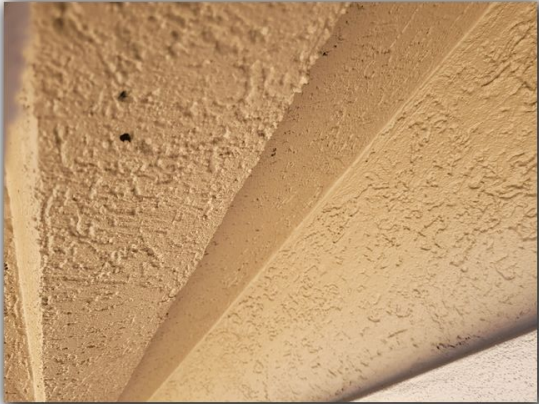
G - 2: Evidence of a previous inspection (holes) was found during the inspection. The inspector identified one unsealed hole from the previous inspection and sealed it.

G- 2.1 Test holes unsealed

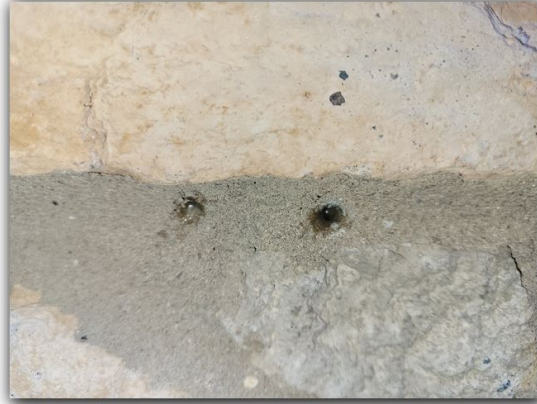
G- 2.2 Test holes in mortar

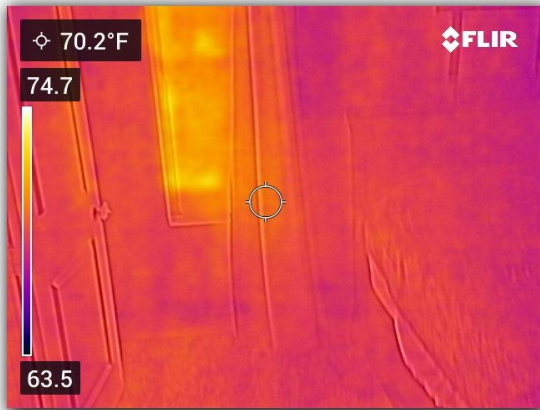
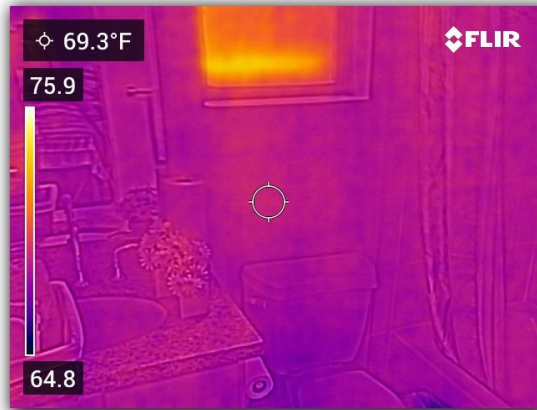
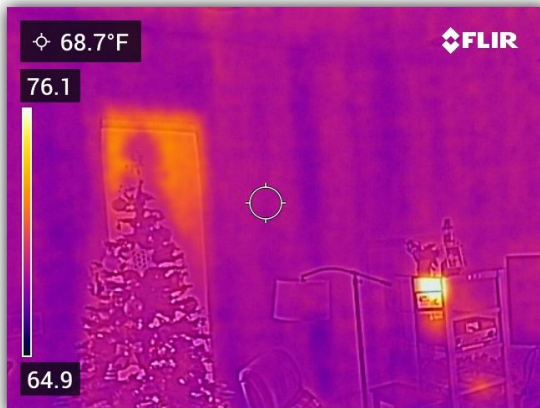
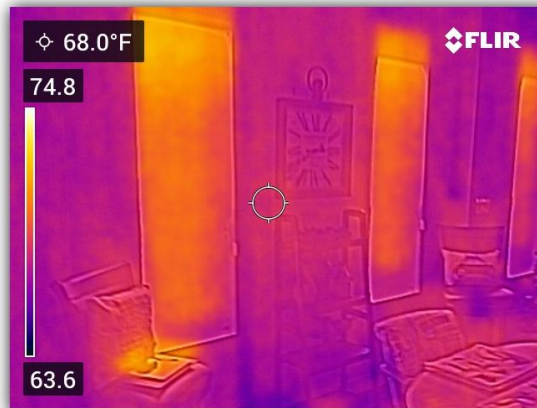
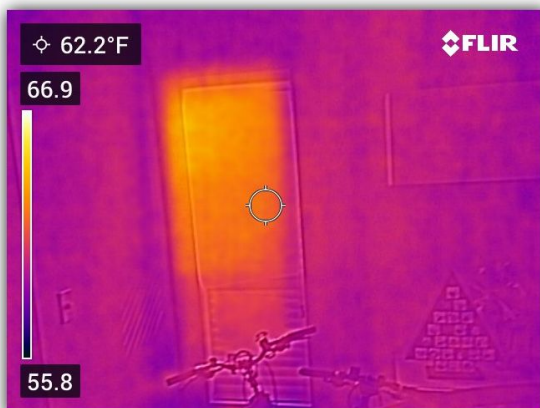
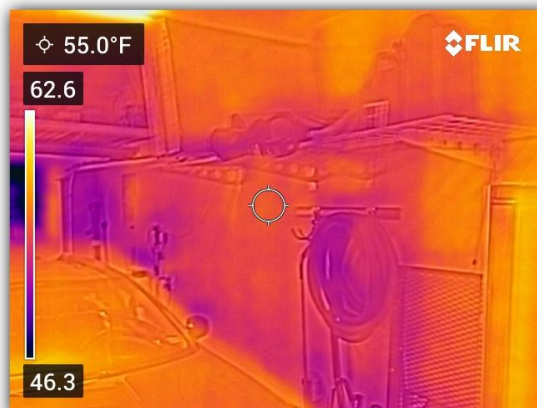
No abnormalities were discovered with the infrared camera at the time of the inspection. Photos from the inspection are provided below:
