Moisture Inspection Report

Inspected for
John Doe
123 Stucco Road
Houston, TX 77XXX
01/01/01

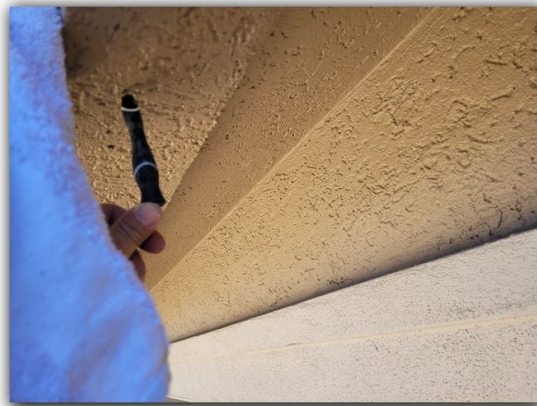
O	<15%	Firm	Diverter flashing not installed at landing and wall intersection.
P	N/A	Soft	Soft substrate was observed when drilling/probing. This is an indication of moisture damage / wood rot. Diverter flashing not installed at landing and wall intersection.
Q	<15%	Firm	Diverter flashing not installed at landing and wall intersection.
R	<15%	Firm	Diverter flashing not installed at landing and wall intersection.
S	<15%	Firm

1- 1.5 Test Location P - Soft substrate encountered

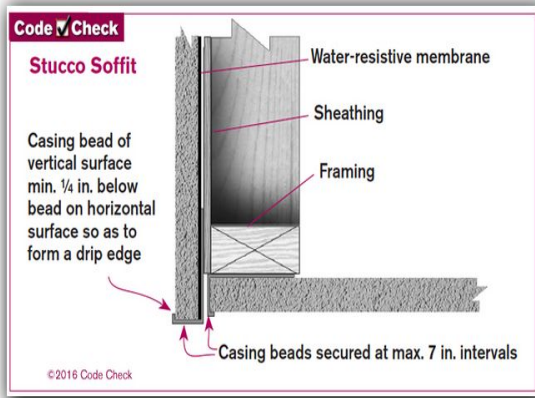
1- 7.1

1 - 7: Missing Drainage Openings: Drainage openings are not installed at the stucco walls / soffit. Drainage openings assist with allowing incidental moisture to escape. Incidental moisture can become trapped in these enclosed areas, sometimes referred to as a "stucco bucket". This trapped moisture can lead to wood rot at the substrate and framing. If elevated moisture or possible substrate / framing damage was found, a drainage opening should be installed during repairs.

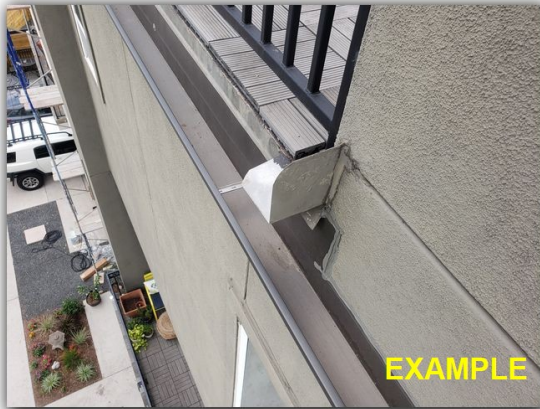
3- 3.1

3 - 3: Balcony Diverter Flashing Missing: Diverter flashing has not been installed at the wall and balcony intersections. Diverter flashing helps to prevent moisture intrusion and allow water to properly drain away from the wall. It is recommended to install diverter flashing when elevated moisture or damage is covered as a result of the missing flashing.

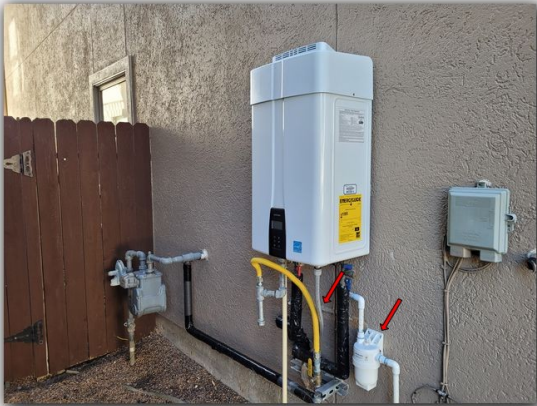
4- 1.4 Seal vent damper

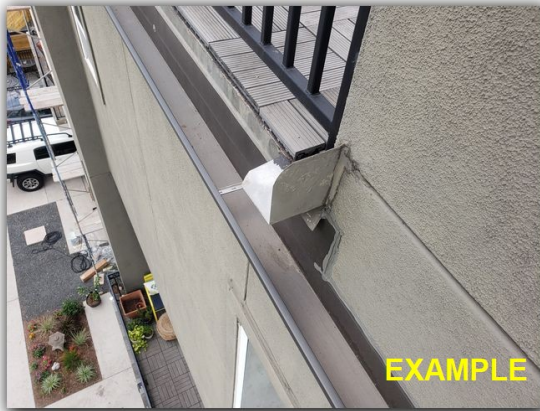
4- 3.1

4 - 3: Balcony Diverter Flashing Missing: Diverter flashing has not been installed at the wall and balcony intersections. Diverter flashing helps to prevent moisture intrusion and allow water to properly drain away from the wall. It is recommended to install diverter flashing when elevated moisture or damage is covered as a result of the missing flashing.
